Manhole Inspection Summary

Manhole # S02WW1016MH

Insp Date: **7/26/06 9:59 AM**

Location Address: **3615 FORDS LN** Cross Street: **FIELDCREST RD**

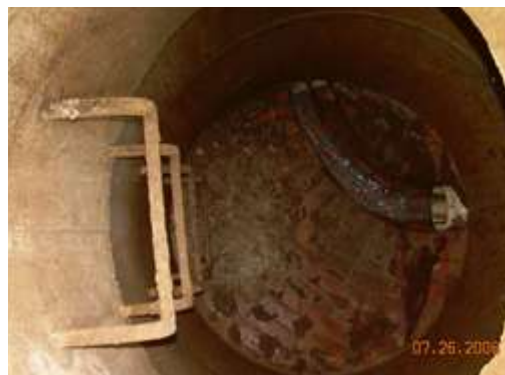
Top View

Chimney / Frame Adjustment ☒ Exists Material: **Brick** ☐ Parged Height: **3** (in.)
Condition: ☒ Sound ☐ Cracked ☐ Root Intrusion ☐ Loose Brick ☐ Deteriorated
Infiltration: ☐ None ☒ **Joint** ☐ Cracks ☐ Mortar ☐ Roots ☐ Wall

Corbel Material: **Precast Concrete** ☐ Parged Type: **Concentric/Eccentric**
Condition: ☒ Sound ☐ Cracked ☐ Root Intrusion ☐ Loose Brick ☐ Deteriorated
Infiltration: ☐ None ☒ **Joint** ☐ Cracks ☐ Mortar ☐ Roots ☐ Wall

Surcharge ☒ **Evidence Of Surcharge** Depth: **1** (ft.) ☐ Active Surcharge Present

Adjustment and Corbel infiltration.
Evidence of surcharge - Bench debris.

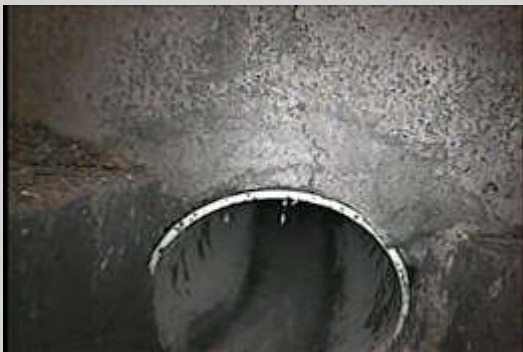
8 in. Circular Gravity Sewer Pipe Out @ 12 O'Clock

Infiltration: **None** Pipe Seal Cond: **Sound**

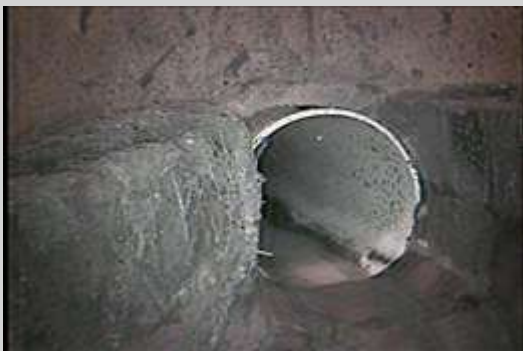
8 in. Circular Gravity Sewer Pipe In @ 3 O'Clock

Comments **The I3 pipe picture shows Bench root intrusion.**

Bench ☒ Exists Material: **Brick** ☐ Parged ☒ **Debris** (not Condition related)
Condition: ☐ Sound ☐ Cracked ☒ **Root Intrusion** ☐ Deteriorated ☐ Leaks ☐ Debris

Also shows Roots

Infiltration: **Evidence** Pipe Seal Cond: **Unknown**
